# PANDUIT PRODUCT SAFETY ADVISORY (PSA)

Reference: PSA09182018001

## IMPORTANT SAFETY INFORMATION REGARDING PANDUIT UNINTERRUPTIBLE POWER SUPPLIES (UPS) AND NETWORK ZONE SYSTEMS WITH UNINTERRUPTIBLE POWER SUPPLIES

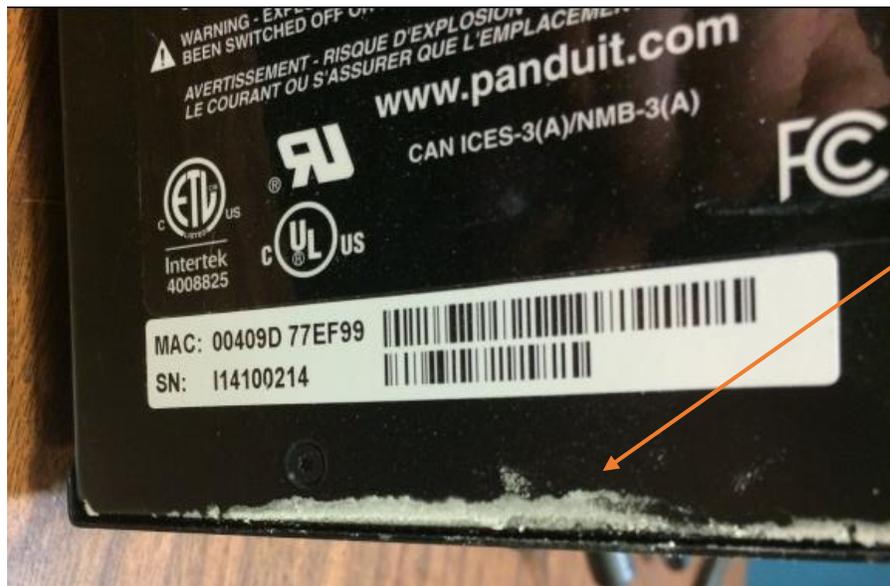
**FIGURE 1**

**POTENTIAL SAFETY HAZARDS.** The capacitor is an electronic product that contains primarily non-hazardous materials, but the sealed capacitors contain two potentially hazardous substances, acetonitrile and Tetraethylammonium tetrafluoroborate. If the UPS is charged at a high level and/or the temperature of the capacitor exceeds the suggested operating temperature at its given lifetime (see User Manual for suggested charging and operating temperatures

<https://www.panduit.com/content/dam/panduit/en/products/assets/u/up/ups/ups0/ups00100dc/media/N-PUCD-0009--REV04--ENG.pdf>), these hazardous substances may vent or leak onto the outside of the UPS housing. A failed unit can present itself as a white powder on the lowest part of the UPS. Figure 1 shows a UPS where the ultracapacitors have vented.

White powder indicating a failed unit.

***If you have an Affected Product, visually inspect the UPS for signs of leaking as shown in Figure 1. Do not install the Firmware Update if there are visual signs that the capacitors are leaking. Instead, remove the unit from service and replace it, following the PRECAUTIONS section of this PSA.***

After installing the Firmware Update, if the UPS displays “End of Life” on the Module page of the Web Interface or if the UPS housing looks like the photos in Figure 1, remove the Affected Product as soon as possible. Engineering controls and PPE, such as gloves and safety goggles, should be used when handling any UPS that has leaked. Do not open any of the non-functional units. Place the non-functional units in a sealed plastic bag and dispose of them with your electronics waste.
